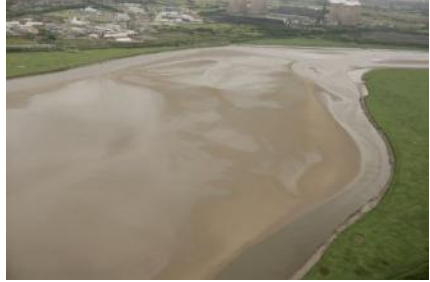
5.4	166.4	0.5	The ebb flow has been equally distributed between two channels as the main channel bifurcates at the upstream end of the reach, one following the northern bank and the other, the southern bank.	No secondary channel visible.	-	-	-	-	Relict low flow channels visible across the main bar.	-

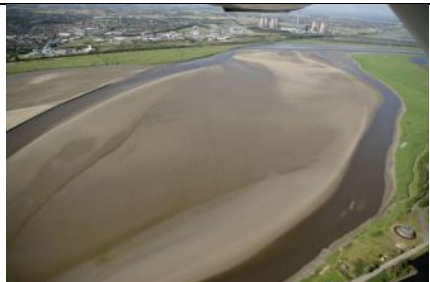
4.3	261.8	0.4	The inlet of the southern branch has accreted notably, as three low flow channels cutting across the point bar of the upstream meander and the upstream apex of the main bar now connect the southern channel branch to the main channel at the upstream end of the reach.	No change.	No change.	Three flood levees visible on the main bar, on its northern, southern and upstream edges.	None.	None.	No change.	Neap 22/07/07 Spring 30/07/07 Neap 07/07/07 Spring 14/07/07 Neap 22/07/07	
28/08/07 10:14 BST	V3_0708_ZM6P4592

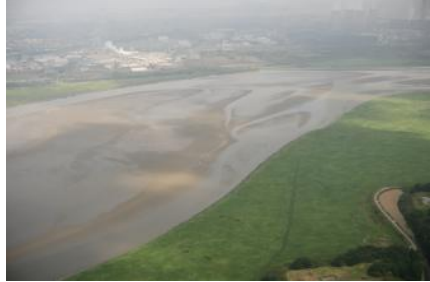
2.9	334.1	0.6	The inlet of the southern channel has widened notably as the low flow channel closest to the southern bank has developed into a main inflow channel to the southern branch.	No change.	No change.	The flood levee across the upstream end of the main bar has been eroded.	None.	None.	No change.	Spring 30/08/07 Neap 05/08/07 Spring 13/08/07 Neap 21/08/07 Spring 28/08/07

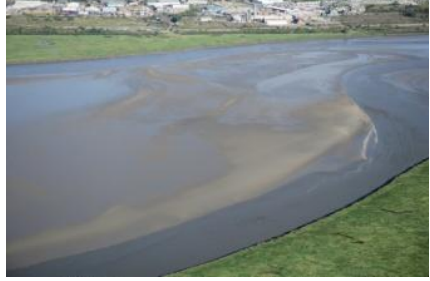
6.0	3.1	0.6	The southern channel is now connected to ebb flow at the upstream end of the reach via one channel, which meanders around the point bar of the southern meander.	No change.	Increased.	A new point bar has developed off the southern meander at the upstream end of the reach.	None.	None.	No change.	Neap 04/09/07 Spring 11/09/07 Neap 19/09/07 Spring 26/09/07

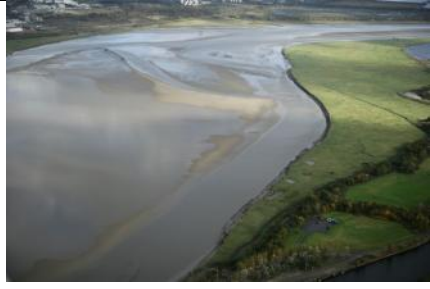
5.7	285.2	0.7	New low flow channels have developed across the upstream end of the main bar and the southern bank's point bar, thus creating a multi channel inlet to the southern branch.	No change.	Decreased.	A new flood levee has been deposited at the upstream edge of the main bar.	None.	None.	No change.	Neap 03/10/07 Spring 11/10/07 Neap 19/10/07 Spring 26/10/07
27/11/07 10:47 GMT	V3_0711_ZM6P7721

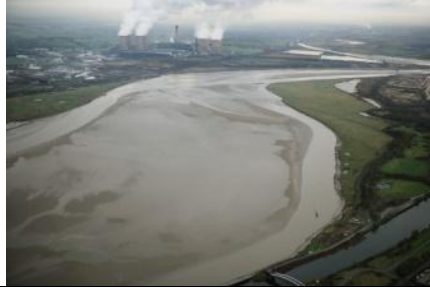
2.0	211.4	0.7	The main ebb flow has been restricted to the previous northern branch as the inlet of the southern branch has accreted notably.	The previous southern branch has formed a secondary channel.	No change.	The point bar of the southern meander and the upstream apex of the main bar have started to combine.	None.	None.	No change.	Neap 01/11/07 Spring 09/11/07 Neap 17/11/07 Spring 24/11/07
13/12/07 11:09 GMT	V3_0712_ZM6P8005

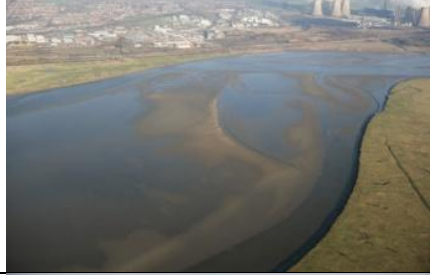
6.2	172.8	0.5	No change.	No change.	No change.	No change.	None.	None.	No change.	Neap 01/12/07 Spring 09/12/07

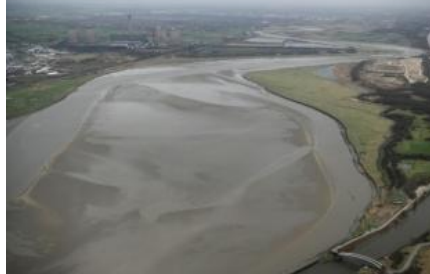
5.3	261.5	0.5	No change.	No change.	No change.	No change.	None.	None.	There is a breach on the southern flood levee created by a relict low flow channel. A shallow channel is cutting across the upstream apex of the main bar.	Neap 17/12/07 Spring 24/12/07 Neap 31/12/07 Spring 08/01/08 Neap 15/01/08 Spring 22/01/08
27/02/08 12:46 GMT	V3_0802_ZM6P9281

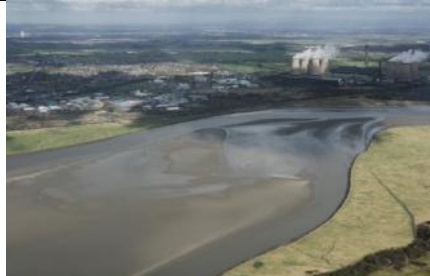
4.1	265.3	0.4	No change.	No change.	No change.	No change.	None	None	Breach on the southern levee has been sealed off.	Neap 30/01/09 Spring 07/02/08 Neap 14/02/08 Spring 21/02/08
23/03/08 10:25 GMT	V3_0803_ZM6P0947

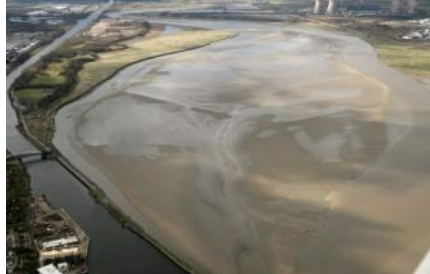
6.7	4.5	0.5	No change.	No change.	No change.	A number of low flow channels are eroding across the main bar. In addition, a flood channel has intruded into downstream apex of the main channel.	None	None	A new breach on the southern levee has been created by a low flow channel.	Neap 29/02/08 Spring 07/02/08 Neap 14/03/08 Spring 21/03/08

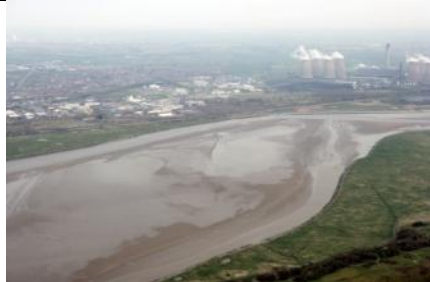
4.2	55.4	0.5	No change.	The upstream reach of the secondary channel has almost entirely accreted.	No change.	Relict low flow channels visible on the main bar. The flood intrusion channel at the downstream apex of the main bar has increased significantly and eroded away a large part of the main bar.	None	None	Breach on the southern levee has been sealed off.	Neap 29/03/08 Spring 06/04/08 Neap 12/04/08 Spring 20/04/08	
21/05/08 10:54 BST	V3_0805_ZM6P1899

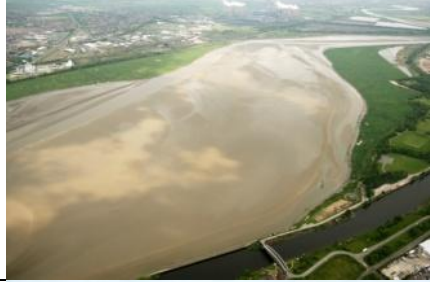
4.7	116.7	0.5	No change.	The upstream reach of the secondary channel has accreted even further.	No change.	High tide erosion lines visible on the main bar. A number of relict low flow channels visible on the main bar.	None	None	No change.	Neap 28/04/08 Spring 05/05/08 Neap 12/05/08 Spring 20/05/08	
23/06/08 13:07 BST	V3_0806_ZM6P2271

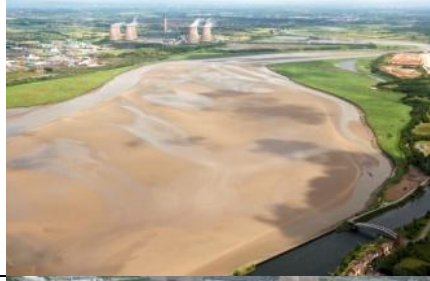
2.9	307.9	0.5	No change.	No change.	No change.	A number of low flow channels visible on the main bar.	None	None	A new breach on the southern levee has been created by a low flow channel.	Neap 28/05/08 Spring 03/06/08 Neap 10/06/08 Spring 18/06/08

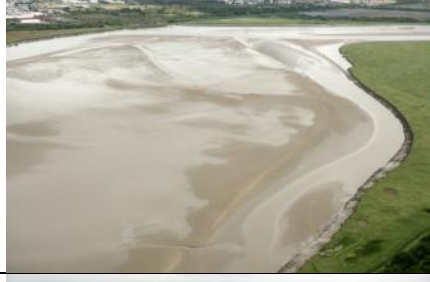
3.2	268.8	0.5	No change.	No change.	No change.	A shallow low flow channel has intruded the upstream apex of the main bar.	None	None	The crevasse on the southern levee has developed further.	Neap 26/06/08 Spring 03/07/08 Neap 10/07/08 Spring 18/07/08	
20/08/08 12:27 BST	V3_0808_ZM6P3408

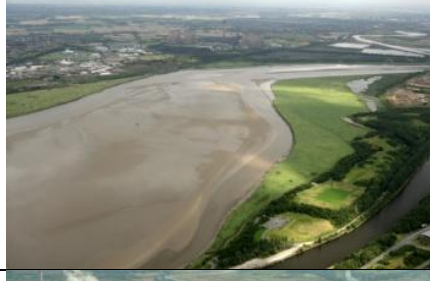
3.2	230.6	0.6	No change.	No change.	No change.	No change.	None	None	The crevasse on the southern levee has slightly accreted.	Neap 25/07/08 Spring 01/08/08 Neap 08/08/08 Spring 16/08/08	
17/09/08 11:25 BST	V3_0809_E02T5497

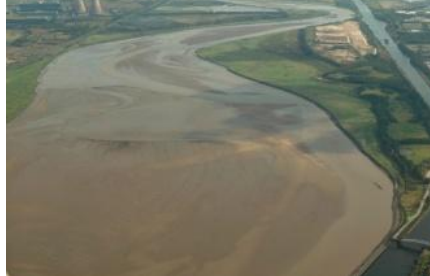
3.6	140.3	0.6	The main channel is now meandering from the northern bank at its upstream end across to the southern side and follows the southern bank throughout the rest of the reach.	A small secondary channel is now following the northern bank.	Increased.	High tide erosion lines visible on the main bar. A number of relict flow channels visible on the main bar.	None	The main and secondary channels have switched sides.	Flood levees on both, northern and southern sides of the main bar have been eroded.	Neap 24/08/08 Spring 30/08/08 Neap 07/09/08 Spring 15/09/08

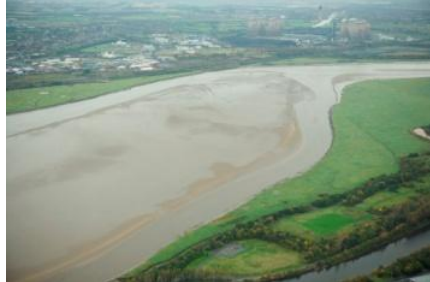
3.3	277.2	0.7	Ebb flow has distributed equally between two channels, one following the northern and the other the southern bank.	No secondary channel.	Decreased	A number of low flow channels are visible on the upstream end of the main bar.	None	None	Continuous flood levees have been re-established on the northern and southern edges of the main bar.	Neap 22/09/08 Spring 29/09/08 Neap 07/10/08 Spring 14/10/08
16/11/08 10:59 GMT	V3_0811_M6P5173

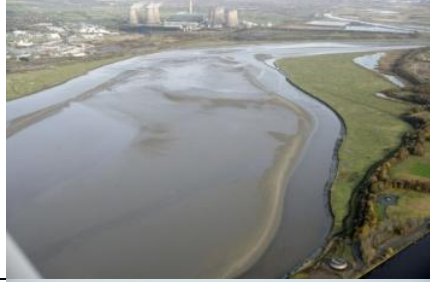
4.0	340.1	0.7	No change.	No change.	No change.	No change.	None	None	No change.	Neap 21/09/08 Spring 28/09/08 Neap 06/10/08 Spring 13/10/08
17/12/08 12:34 GMT	V3_0812_M6P5548

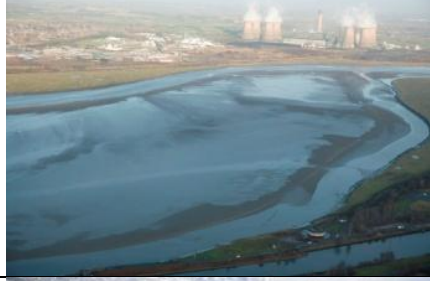
5.0	237.5	0.6	The previous northern branch has developed into a main channel.	The previous southern branch has developed into a secondary channel. Increased sinuosity of the secondary channel.	No change.	High tide erosion lines visible on the main bar.	None	None	The northern and southern levees have been both breached by low flow channels.	Neap 19/11/08 Spring 27/11/08 Neap 05/12/08 Spring 12/12/08

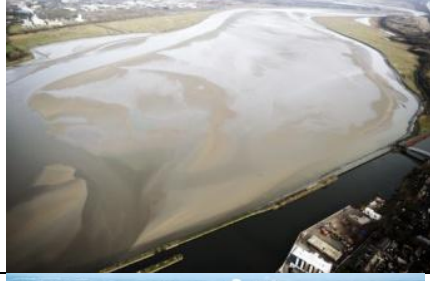
5.7	166.1	0.6	No change.	The secondary channel has accreted notably.	No change.	No change.	None	None	No change.	Neap 19/12/08 Spring 27/12/08 Neap 04/01/09 Spring 11/01/09
16/02/09 13:42 GMT	V3_0902_M6P6686

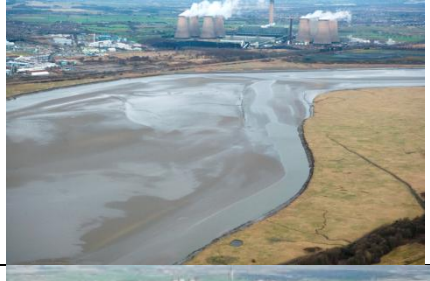
5.3	278.1	0.4	No change.	No change.	No change.	No change.	None	None	No change.	Neap 18/01/09 Spring 26/01/09 Neap 02/02/09 Spring 09/02/09 Neap 16/02/09
15/03/09 11:58 GMT	V3_0903_M6P6686

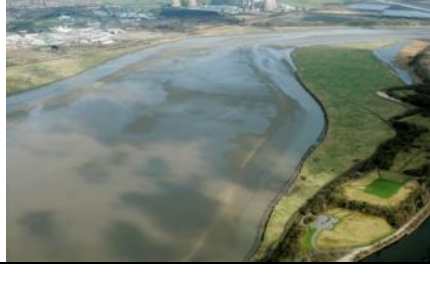
2.8	273.4	0.5	No change.	The inlet of the secondary channel has accreted ever further.	No change.	Relict low flow channels visible on the main bar.	None	None	All breaches on flood levees have been sealed off.	Spring 25/02/09 Neap 04/03/09 Spring 11/03/09

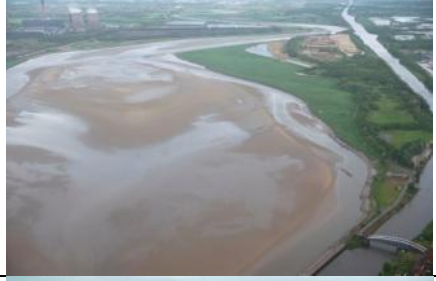
7.0	191.0	0.4	No change.	The secondary channel has accreted notably around the central part of its reach.	No change.	Relict low flow channels visible on the main bar.	None	None	No change.	Spring 25/04/09 Neap 01/05/09 Spring 09/05/09
19/06/09 18:18 BST	V3_0906_M6P7854	 	4.7	273.7	0.5	No change	No change	Increased sinuosity of both, main and secondary channels.	No change.	None.	None.	A low flow channel has developed a breach into the southern levee.	Neap 17/05/09 Spring 24/05/09 Neap 31/05/09 Spring 07/06/09 Neap 15/06/09

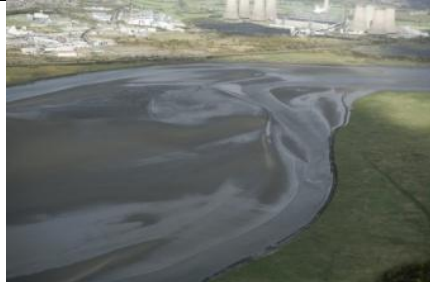
8.2	245.4	0.4	No change visible.	No change visible.	Increased.	The point bar off the southern bank at the upstream end has continued to develop.	None.	None.	A new breach on the southern flood levee has been created by a shallow low flow channel.	Neap 26/09/09 Spring 04/10/09 Neap 11/10/09 Spring 18/10/09	
23/11/09 12:52 GMT	V3_0911_M6P0407

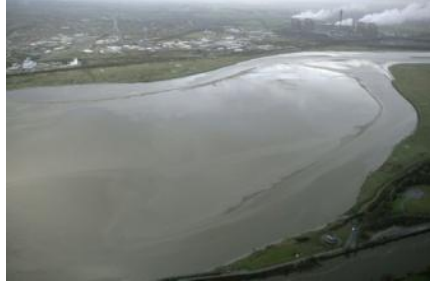
5.5	280.7	0.5	No change	No change	Decreased	A new channel has branched off the northern main channel at its upstream end and eroded across the main bar, providing a new connection to the southern main channel while the developing point bar of the southern bank has started to combine with the upstream apex of the cut off sediment bar.	None.	None.	No crevasses visible on the flood levees.	Neap 26/10/09 Spring 02/11/09 Neap 09/11/09 Spring 16/11/09	
20/12/09 11:07 GMT	V3_0912_M6P0776

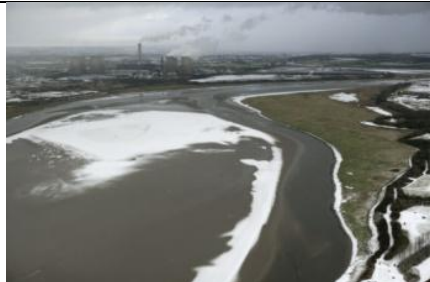
7.8	271.6	0.5	No change	No change	No change	The sediment bar at the upstream end of the reach previously cut off by a channel branching off the northern main channel has re-combined with the main bar, while the abandoned channel is still visible. The point bar of the southern bank at the upstream meander has notably reduced in size.	None.	None.	No change.	Neap 24/11/09 Spring 02/12/09 Neap 09/12/09 Spring 16/12/09

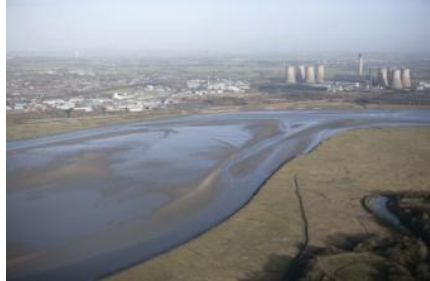
3.9	253.0	0.5	The previous northern branch has developed into a new main channel.	The previous southern branch has developed into a secondary channel.	No change.	An elongated sediment bar has developed off the southern bank at the upstream end of the reach and thus, narrowed the inlet of the southern channel.	None.	None.	A low flow channel has developed a breach into the flood levee on the southern edge of the main bar.	Neap 24/12/09 Spring 31/12/09 Neap 07/01/10 Spring 15/01/10	
19/02/10 12:09 GMT	V3_1002_M6P1461

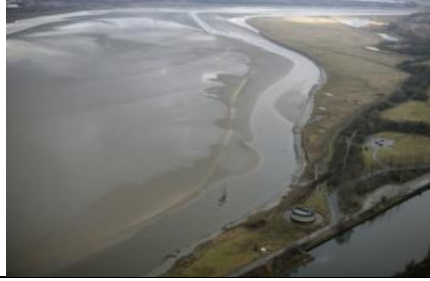
4.2	279.9	0.4	No change.	Increased sinuosity of the secondary channel	No change visible.	High tide erosion lines visible on the main bar.	None.	None.	No change.	Neap 23/01/10 Spring 30/01/10 Neap 05/02/10 Spring 14/02/10

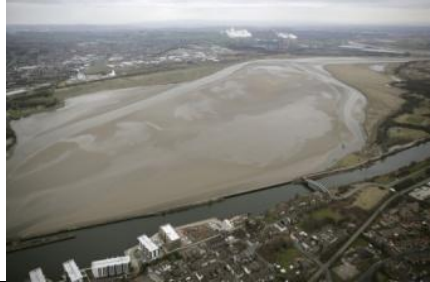
23/03/10 14:04 GMT	V3_1003_M6P1961

4.0	182.9	0.3	No change	The previous inlet of the secondary channel has accreted notably.	No change	A number of low flow channels visible on the main bar.	None.	None.	No change.	Neap 22/02/10 Spring 28/02/10 Neap 07/03/10 Spring 15/03/10 Neap 23/03/10	
20/04/10 14:00 BST	V3_1004_M6P2257

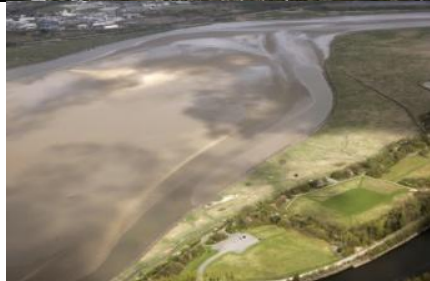
3.2	285.8	0.5	No change.	No change.	No change.	No change.	None.	None.	No change.	Spring 03/04/10 Neap 06/04/10 Spring 14/04/10	
26/05/10 05:55 BST	V3_1005_a_M6P2820

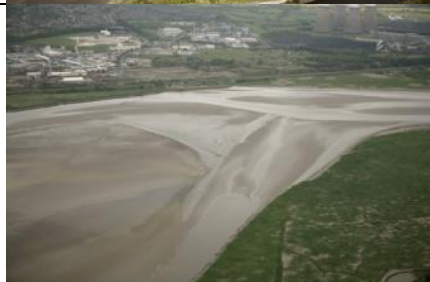
2.9	68.4	0.7	No change.	No change.	No change.	High tide erosion lines visible on the main bar.	None.	None.	No change.	Neap 21/04/10 Spring 06/05/10 Neap 14/05/10 Spring 21/05/10	
17/06/10 14:02 BST	V3_1006_M6P3108

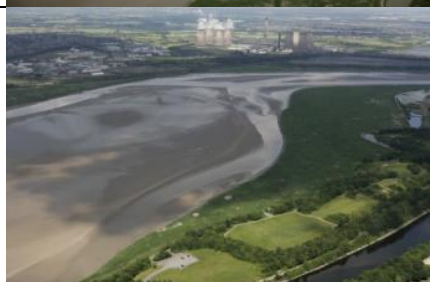
2.7	21.2	0.6	No change.	The inlet of the secondary channel has opened up, creating a pointed apex at the upstream end of the main bar.	No change.	Relict flow channels visible on the main bar.	None.	None.	Continuous flood levee on the southern edge of the main bar with no crevasses.	Neap 28/05/10 Spring 04/06/10 Neap 12/06/10

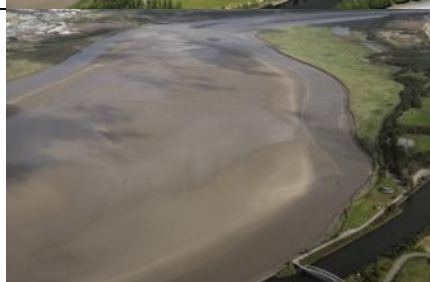
4.4	292.1	0.6	The previous main and secondary channel are now of comparable size.	No secondary channel.	No change.	The point bar of the southern bank at the upstream meander has reduced notably.	The pointed apex of the main bar has migrated closer to the northern bank, hence opening up a bigger inlet for the southern channel.	None.	No change.	Spring 19/06/10 Neap 26/06/10 Spring 04/07/10 Neap 11/07/10 Spring 18/07/10 Neap 26/07/10 Spring 03/08/10 Neap 10/08/10 Spring 16/08/10 Neap 24/08/10 Spring 01/09/10 Neap 08/09/10

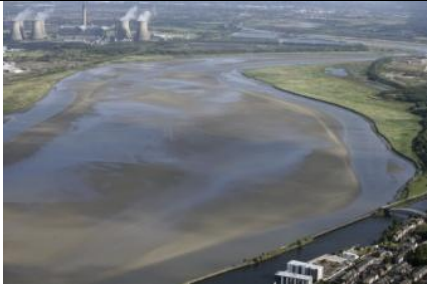
4.8	345.1	0.5	The inlets of both northern and southern channels have accreted notably with the main channel following a central pathway at its upstream end before branching into the northern and southern channel.	No change.	No change.	A number of low channels are visible on the main bar.	The point bar of the southern bank at the upstream end of the reach has migrated to the centre of the channel, now forming a separate moon shaped sediment bar only connected to the southern bank by its upstream apex.	None.	A breach has been eroded into the southern levee at the upstream end of the reach by the new inlet of the southern channel	Spring 15/09/10 Neap 23/09/10	
27/10/10 12:28 BST	V3_1010_a_M6P4694

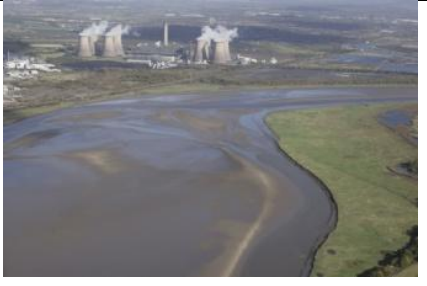
4.5	244.3	0.6	The previous northern branch has developed into a new main channel.	The previous southern branch has developed into a secondary channel. The inlet of the secondary channel has accreted significantly as the channel is now connected to the main flow by a number of small low flow channels which have spread across the upstream end of the main bar.	No change.	A triangular sediment bar has been built up from reworked material at the upstream end of the main bar.	None	None	No breaches in the southern levee.	Spring 01/10/10 Neap 07/10/10 Spring 14/10/10 Neap 23/10/10

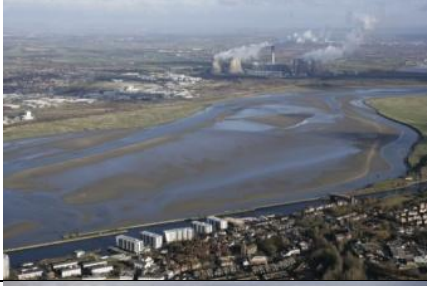
25/11/10 11:13 GMT	V3_1011_M6P4941

4.9	350.4	0.6	No change.	The small low flow channels facilitating inflow into the secondary channel have been replaced by a new inlet.	No change.	A number of relict low flow channels can be seen on the main bar.	None	None	No change.	Spring 30/10/10 Neap 06/11/10 Spring 13/11/10 Neap 21/11/10	
11/12/10 12:42 GMT	V3_1012_M6P5096

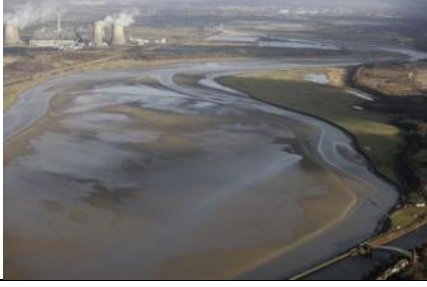
2.6	292.0	0.5	No change.	The inlet of the secondary channel has accreted notably.	No change.	A previously abandoned channel cutting across the upstream end of the main bar has been reactivated.	None	None	No change.	Spring 28/11/10 Neap 05/12/10

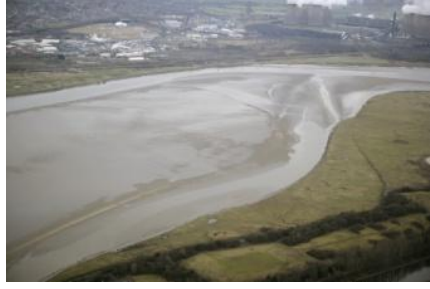
23/01/11 11:39 GMT	V3_1101_M6P5254

3.7	5.6	0.6	No change.	The secondary channel has accreted further.	No change.	No change.	None	None	No change.	Spring 13/12/10 Neap 21/12/10 Spring 28/12/10 Neap 04/01/11 Spring 12/01/11 Neap 19/01/11	
23/02/11 12:42 GMT	V3_1102_M6P5511

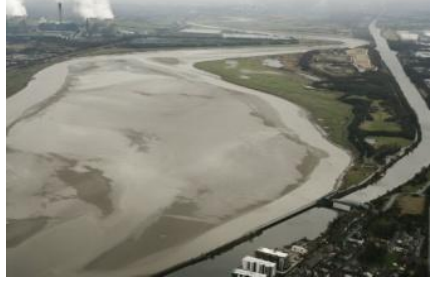
3.6	216.9	0.5	No change.	The secondary channel has widened considerably while two inlet channels now connect it with the northern main channel.	No change.	No change.	The point bar of the southern bank at the upstream end has migrated to the centre of the channel, now forming a triangular sediment bar separate from the embankment.	None	No change.	Spring 26/01/11 Neap 03/02/11 Spring 11/02/11 Neap 18/02/11	
21/03/11 10:18 GMT	V3_1103_M6P5880

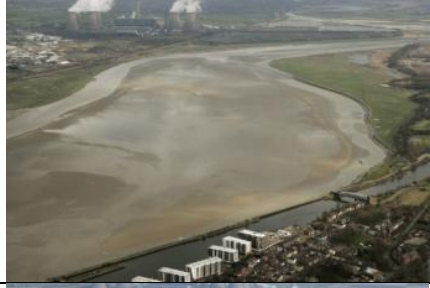
1.8	233.1	0.6	No change.	The secondary channel has accreted notably.	No change.	The triangular sediment bar at the upstream end of the reach has combined with the upstream apex of the main bar.	None.	None.	No change.	Spring 24/02/11 Neap 04/03/11 Spring 12/03/11 Neap 19/03/11

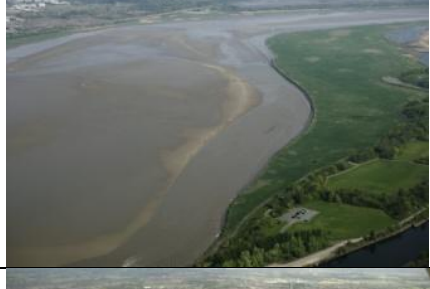
19/04/11 10:56 BST	V3_1104_M6P6305

2.5	31.4	0.6	The previous main and secondary channel are now of comparable size.	No secondary channel.	No change.	The low flow channel across the upstream end of the main bar has been abandoned.	None.	None.	The flood levee on the southern edge of the main bar has been partially eroded.	Spring 26/03/11 Neap 03/04/11 Spring 11/04/11 Neap 18/04/11	
21/05/11 13:00 BST	V3_1105_M6P6706

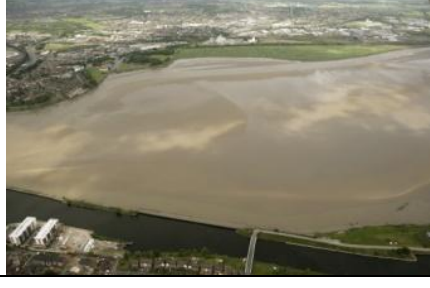
5.5	195.7	0.6	No change.	No change.	No change.	No change visible.	None.	None.	No change visible.	Spring 25/04/11 Neap 03/05/11 Spring 10/05/11 Neap 17/05/11

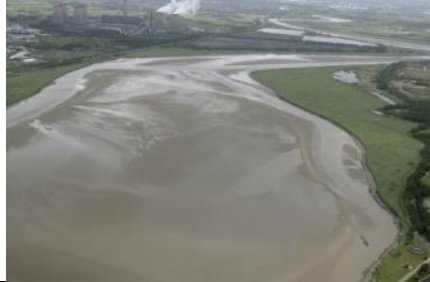
21/06/11 12:46 BST	V3_1106_M6P6994

5.4	230.1	0.7	The previous northern branch has developed into a new main channel.	The previous southern branch has developed into a secondary channel. The inlet of the secondary channel has accreted significantly.	No change.	A number of relict low flow channels are visible on the main bar.	None.	None.	A new sinuous flood levee has been formed on the southern edge of the main bar.	Spring 24/05/11 Neap 01/06/11 Spring 09/06/11 Neap 15/06/11	
19/07/11 12:52 BST	V3_1107_M6P7420

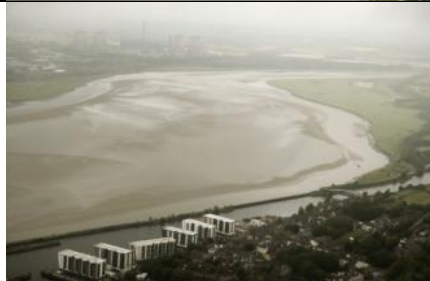
1.9	290.9	0.6	The previous main and secondary channel are now of comparable size.	No secondary channel.	No change.	No change.	None.	None.	No change.	Spring 23/06/11 Neap 01/07/11 Spring 08/07/11 Neap 15/07/11	
19/08/11 13:19 BST	V3_1108_M6P7979

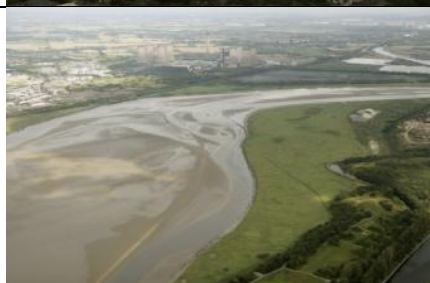
3.4	221.9	0.5	The inlet of the southern channel has developed into a complicated, braided form, while cutting off sediment bars from the upstream part of the main bar.	No change.	The sinuosity of the southern channel has increased.	Two sediment bars cut off from the upstream part of the main bar by one of the inlet channels of the southern channel.	None.	None.	No change.	Spring 23/07/11 Neap 30/07/11 Spring 06/08/11 Neap 13/08/11

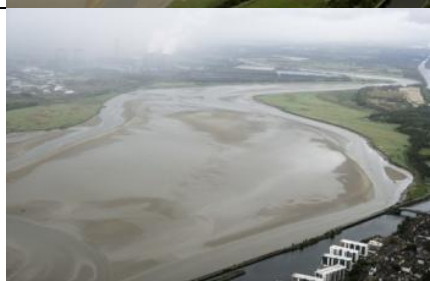
20/09/11 14:38 BST	V3_1109_M6P8159

3.8	225.5	0.4	No change.	No change.	The sinuosity of the southern channel has decreased.	No change.	None.	None.	No change.	Spring 21/08/11 Neap 29/08/11 Spring 04/09/11 Neap 12/09/11 Spring 20/09/11	
16/10/11 12:10 BST	V3_1110_M6P8512

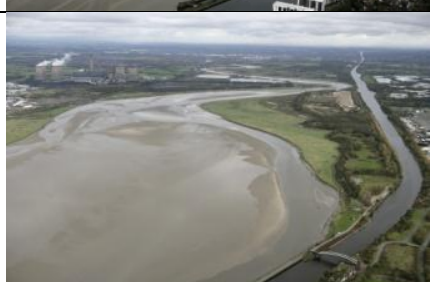
2.9	258.7	0.6	The main flow has now switched to the southern channel while the upstream reach of the channel has migrated to the centre of the estuary.	The previous northern branch has developed into a secondary channel.	Increased.	Due to the migration of southern channel's upstream reach, a sediment bar has been cut off the main bar which has started to combine with the point bar of the southern bank at its upstream meander.	The upstream reach of the southern channel has migrated to the centre of the estuary.	The main flow has now switched to the southern channel.	The southern flood levee has been partially eroded.	Neap 27/09/11 Spring 04/10/11 Neap 12/10/11

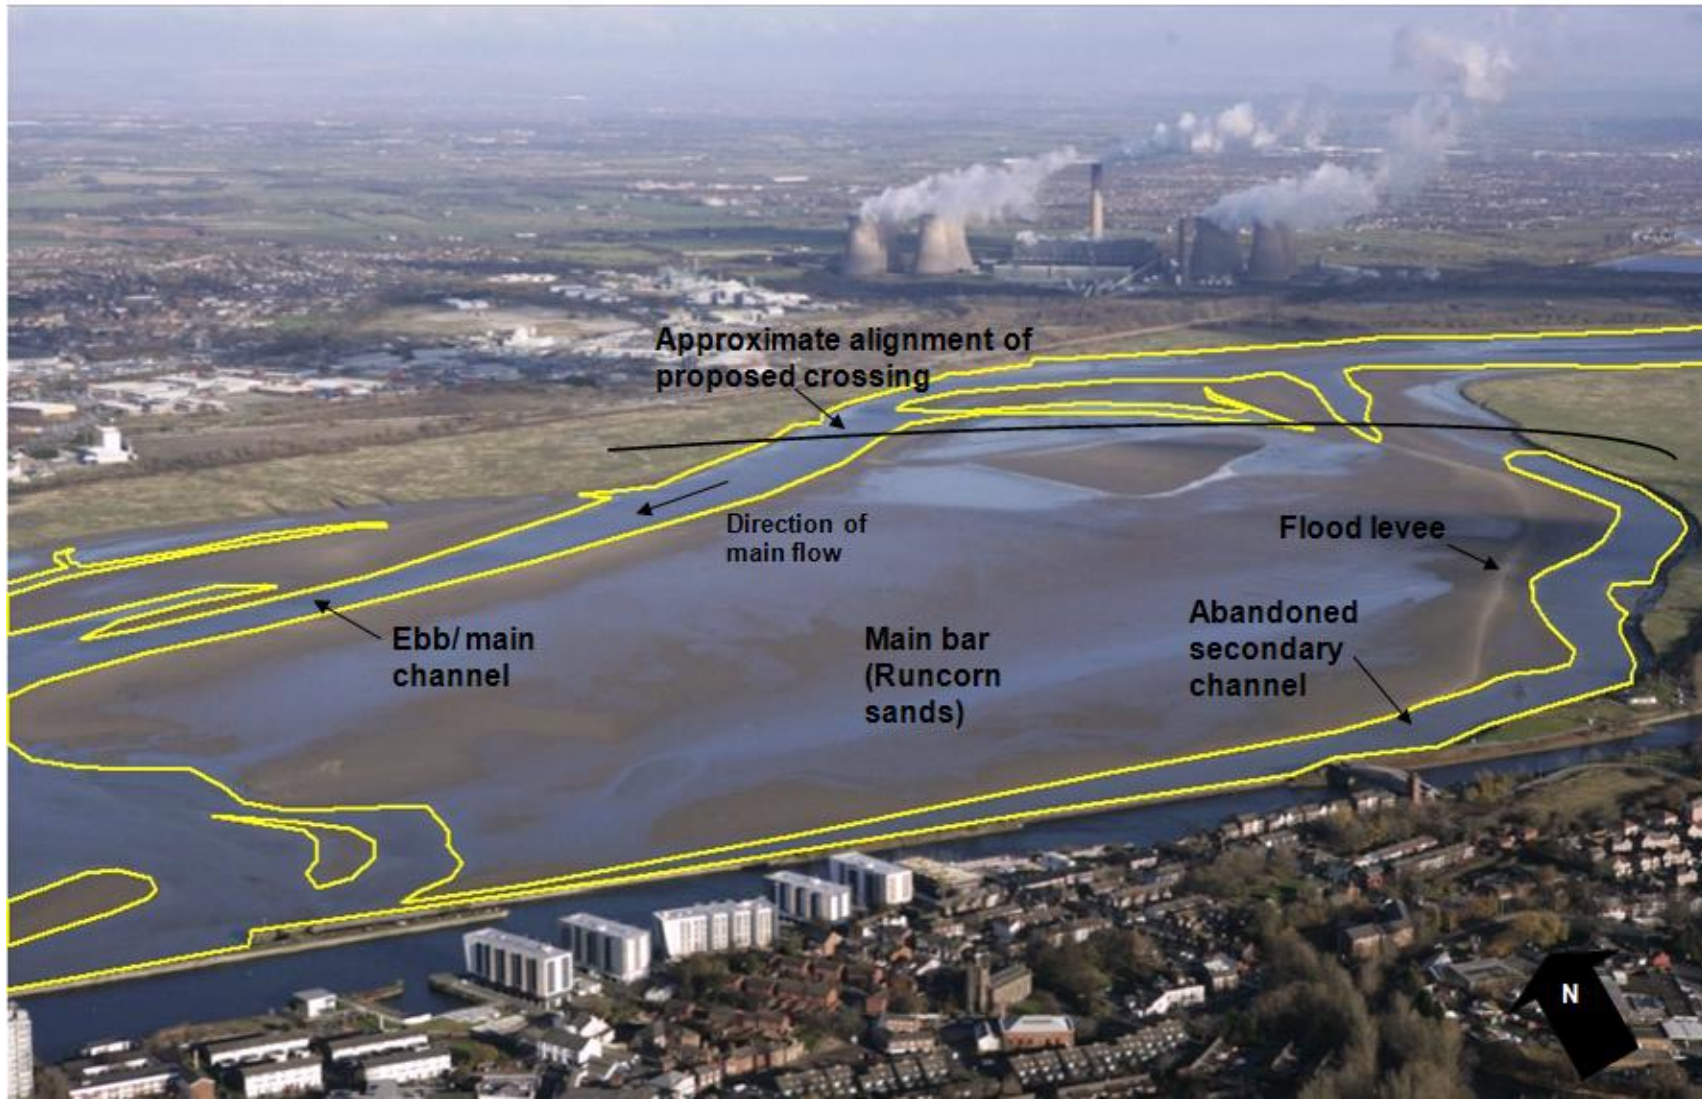
Dominant state of the system: main channel next to the northern bank, secondary channel next to the southern bank. Date: 25/11/10 11:13 GMT LW: 0.6 m

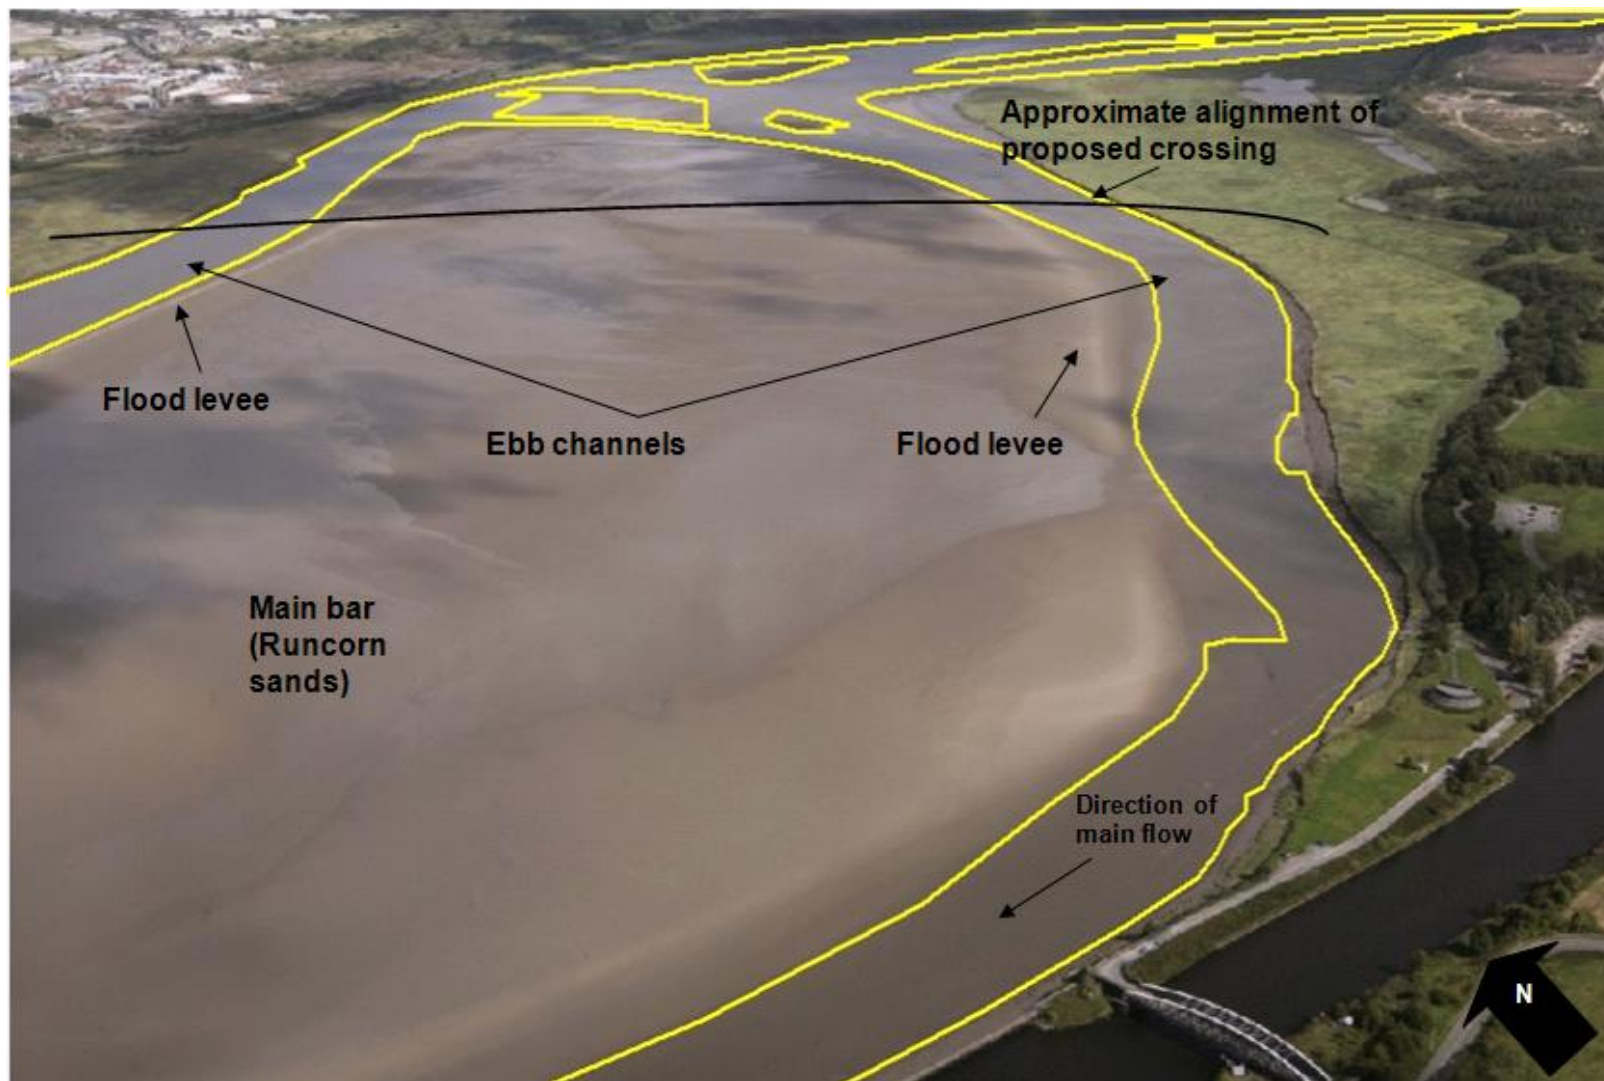
One ebb channel on either side of the main bar. Date: 12/09/10 12:55 BST LW: 0.6 m

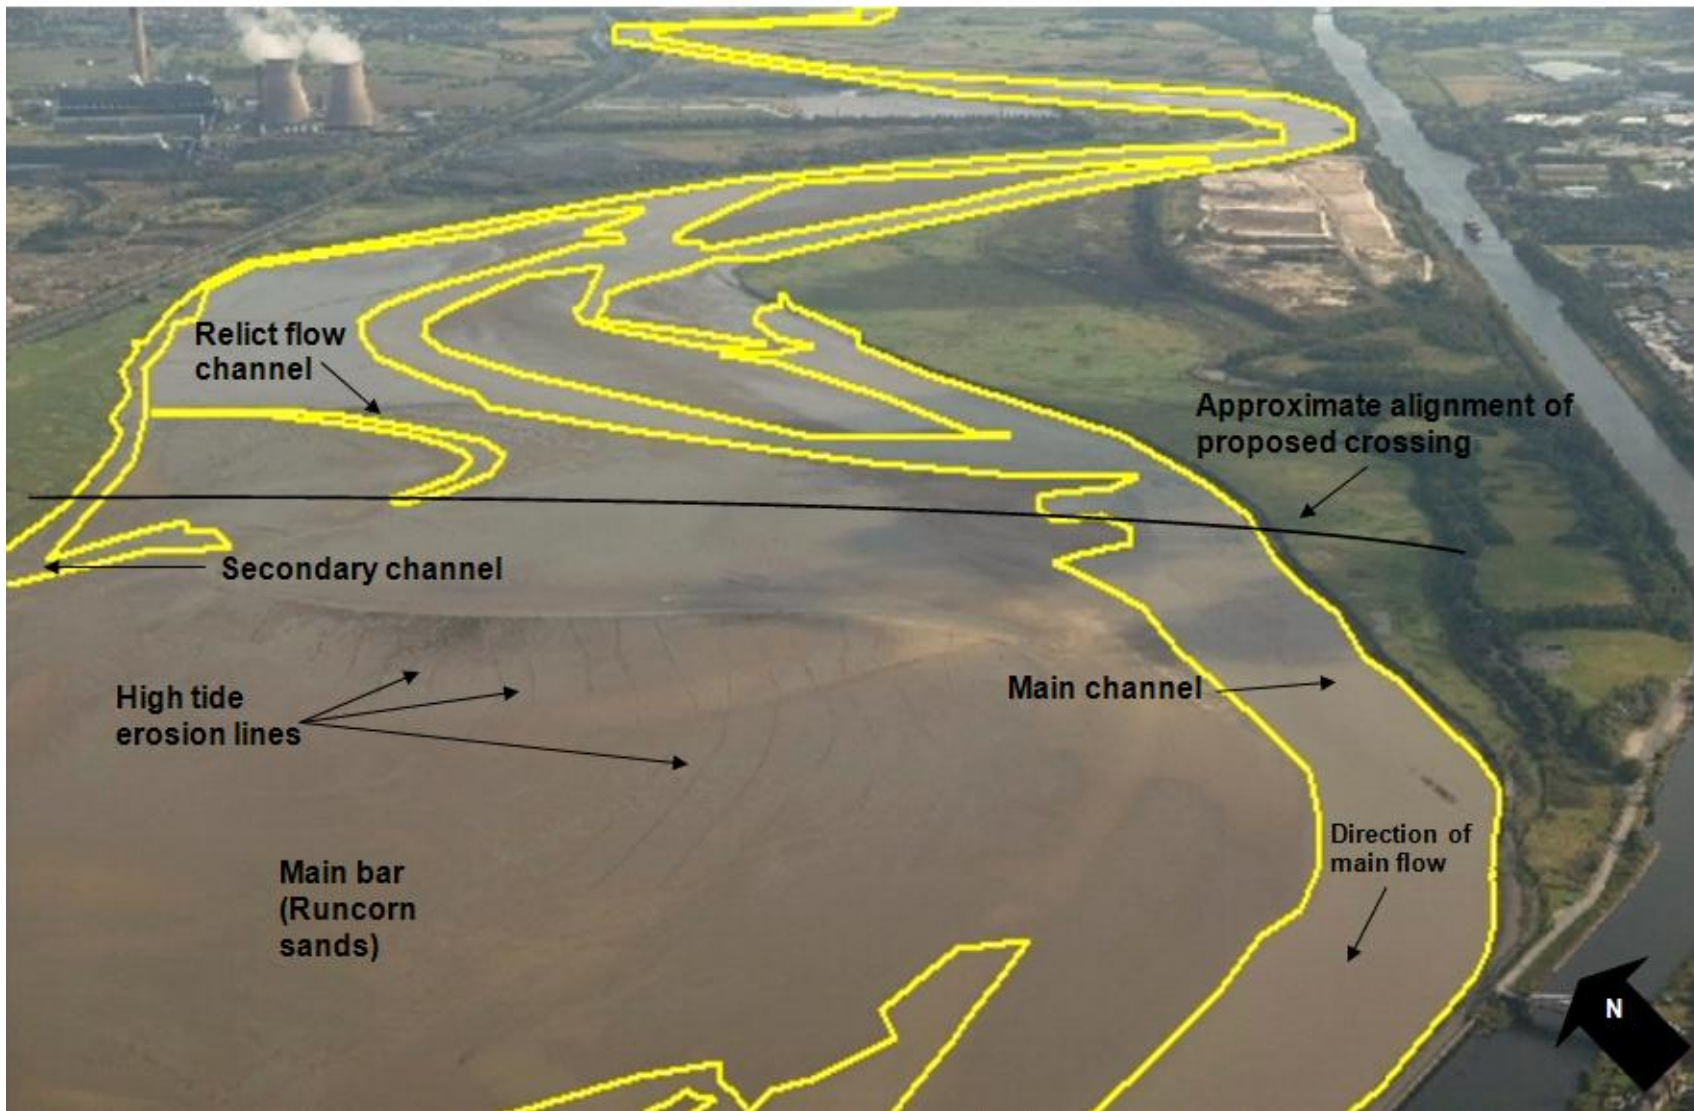
Main channel on the southern side of the main bar. Date: 21/08/09 10:58 BST LW: 0.7 m
